Oil Field Masterpiece

New York Collector's Determination Brings Rare 25 HP 1901 Swan Back to Life

Editor's note: This article is the first of a two-part series chronicling the restoration of a 1901 Swan oil field engine.

25 HP Swan

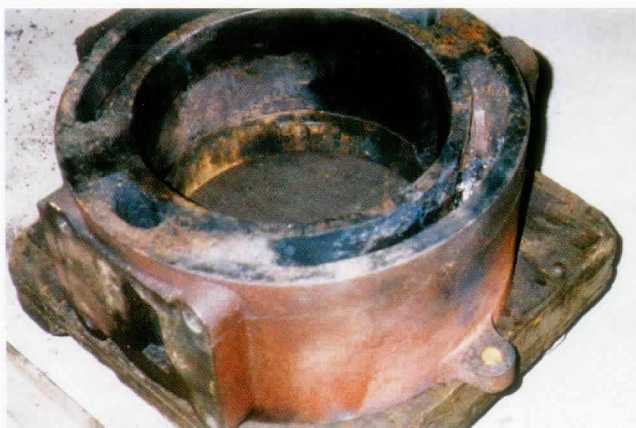
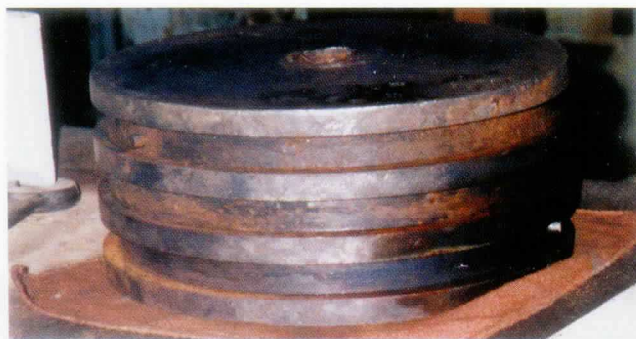
The Swan's combustion chamber after disassembly (left) and piston (above).

Looking at the exposed piston, I discovered why the engine quit running: The threaded end of the connecting rod (the rod shoulders up to the bottom of the piston and a large nut at the top locks the piston and rod together) was broken off even with the top of the piston. That meant nothing was holding the two parts together. I found signs of welding on both the piston and the connecting rod, probably a field-fix to keep the engine running after the rod end broke. Who knows how long that fix lasted.

When the weld eventually broke, the connecting rod came out of the piston, and on the next forward stroke the connecting rod pushed the piston up into the combustion chamber 3 inches farther than normal. This explained why the piston was stuck so close to the head. Thank God for a large combustion chamber, or who knows what other parts would have broken.

I set the combustion chamber with the stuck piston on my press, heated it all up and pressed the piston out. After cleaning the piston, I found it had three rings, and once I got the rings freed up I removed them from the piston. They were shot.

bored and then build up the piston. It really was a no-brainer. The removable cylinder sleeve had to be bored and the piston built back up to the proper clearance with the new bore. At that point in the restoration I didn't have the capability in my shop for cylinder boring, so I sent the cylinder sleeve and piston out to another shop.

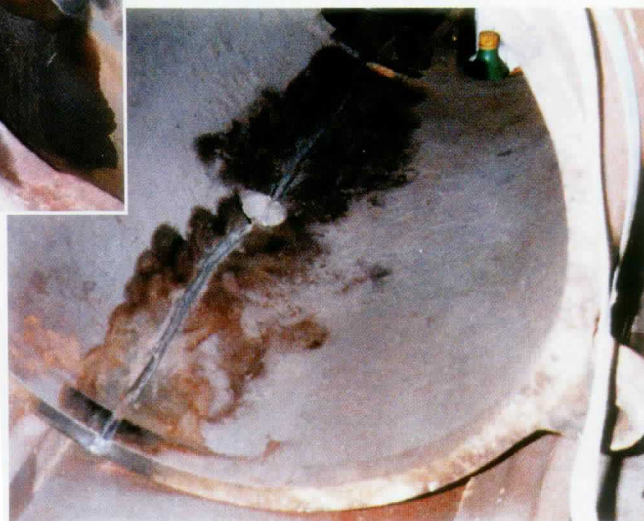
Below: Freeze crack ran the entire length of the cylinder water jacket.

The cast iron cylinder water jacket had a crack on the bottom side running the entire length of the jacket. I cleaned the water jacket up, and using an angle grinder I cut a "V" into the crack on both the inside and outside. With the water jacket ready to weld, I brought the crack together by strapping it tight and then tacked it with Ni-rod using a DC welder. I left the straps on during most of the welding process just to help keep some of the pressure off the new weld. I welded about a half-inch at a time skipping around from the inside to the outside, stopping when I couldn't put my hand on the welded area. Then I peened the weld for a few minutes to help relieve the stress in the weld. This process took about four days to complete. The weld came out really nice and very strong. Next, I ran a pipe tap through the inlet and outlet holes to clean the threads up, followed by a couple of primer coats.

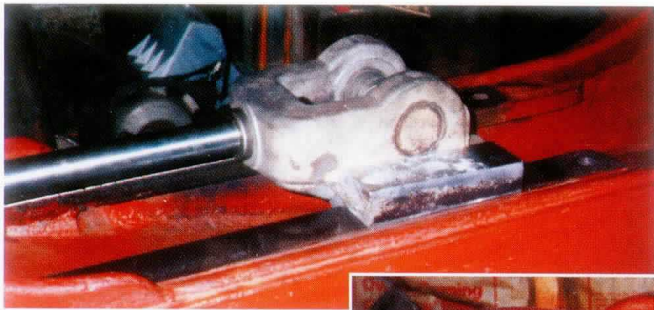
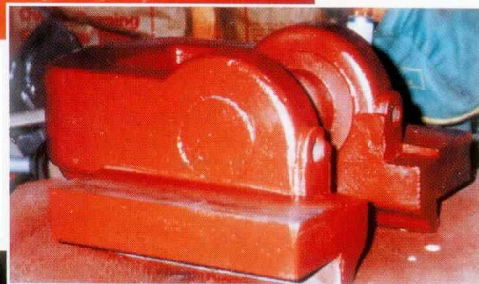
Crosshead after pouring new babbitt (above) and after a coat of primer (right). A freshly babbitted and primered bearing cap (below).

I poured the bearing caps and then put in some hard work cleaning up the bedplate to ready it for primer. I cleaned and sanded the crosshead slide surfaces, removing most of the pits, and I cleaned out or chased all the threaded holes in the bedplate with a tap. I also made new studs for mounting the crosshead top rails. Then I applied a couple of primer coats to the bedplate.

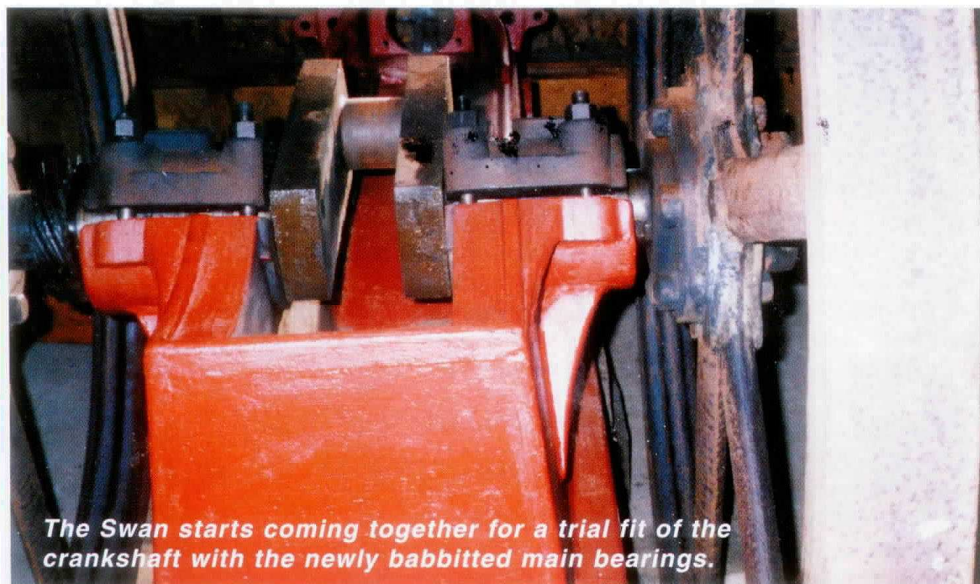
The Swan starts coming together for a trial fit of the crankshaft with the newly babbitted main bearings.

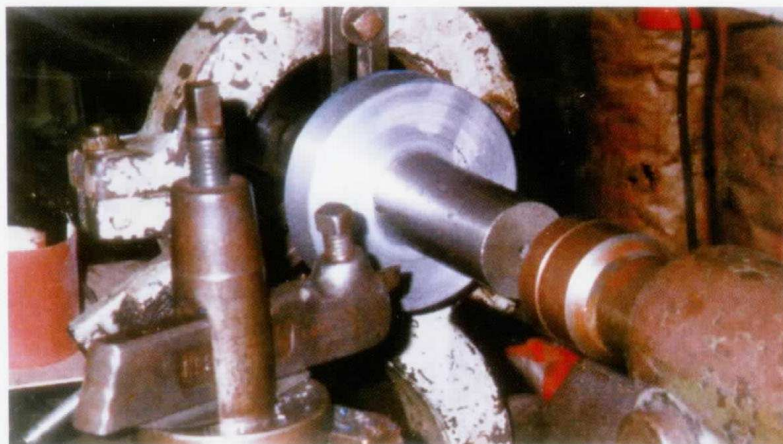
Center: *Machining the cylinder-locating plate.*

Right: *Machining the shoulder on the new piston-connecting rod.*

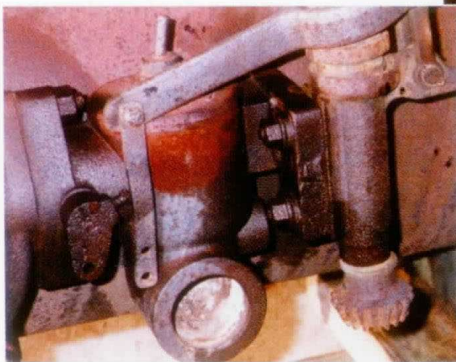
Above: Mixer and governor before disassembly.

The governor assembly was the next part of the restoration to tackle. The governor shaft was rusted solid in the governor housing, and the governor housing had a crack in it from rust and moisture swelling and expanding. The governor parts are pretty fragile, so to make sure nothing broke during disassembly I drilled out all the pins holding the governor balls. I cut off both ends of the center shaft and heated up the housing with a torch. I did this repeatedly – followed by a good soaking in kerosene – but I still couldn't get the parts to free up. Finally, I put the governor housing in a press, and the shaft started to move. The shaft finally came out, and I repaired the cast iron governor housing by welding the crack with Ni-rod and grinding it flush.

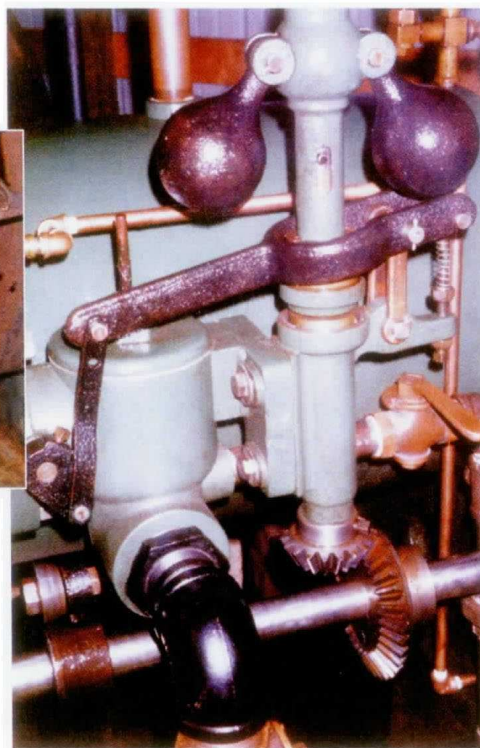
Right: The restored mixer and governor highlight the work that went into this engine's restoration. Note the new governor gears.

With this done, I cut gaskets and put the valve chests on. Next up was the mixer, which needed a little work before I could bolt it up. I re-cut the seat for the gas valve (it holds the gas back until it sees a vacuum from the engine) and made a new shaft for the butterfly valve. I reamed out the shaft holes in the mixer housing and installed new bronze bushings. With that work done the mixer was like new.
